Swains Creek Pines Lot Owners Association

Level 2 Reserve Study

Report Period – 01/01/2023 – 12/31/2023

Type of Study	Update w/Site Visit
Date of Property Inspection	6/3/2022
Prepared By	Dale Gifford
Analysis Method	Cash Flow
Funding Goal	Full Funding

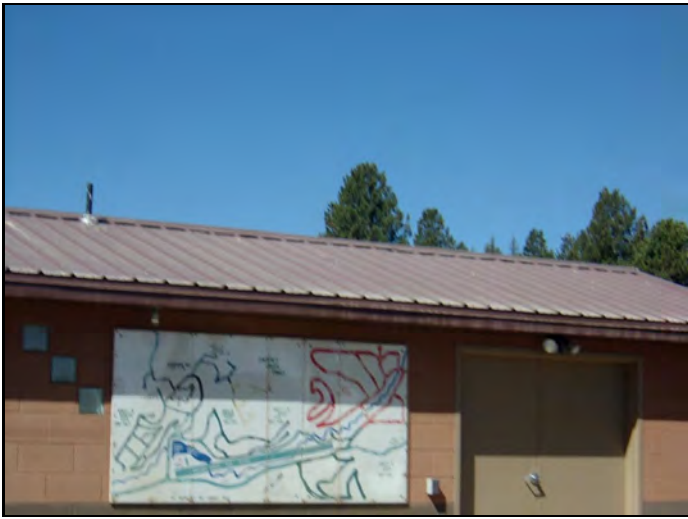
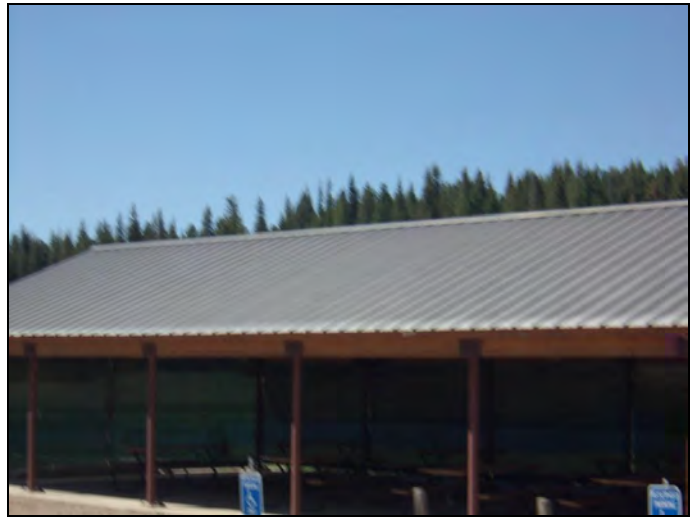
Comp #: 108 Metal Roofs - Replace

The metal roofs are in good condition. We recommend funding to replace this component approximately every 40 - 50 years. Remaining life based on current age.

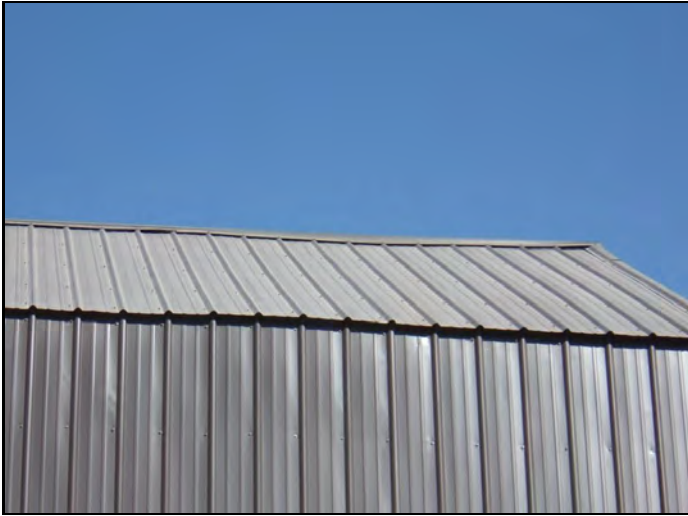
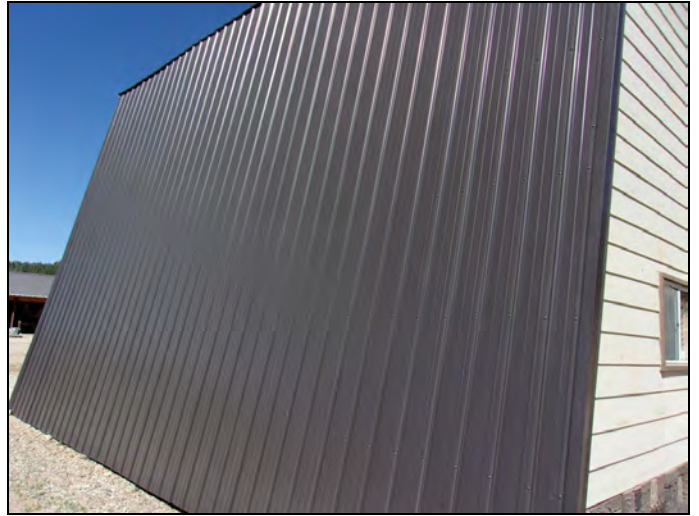
Comp #: 108 Roof - Barn - Replace

The metal roof is in good condition. We recommend funding to replace this component approximately every 40 - 60 years. Remaining life based on current age.

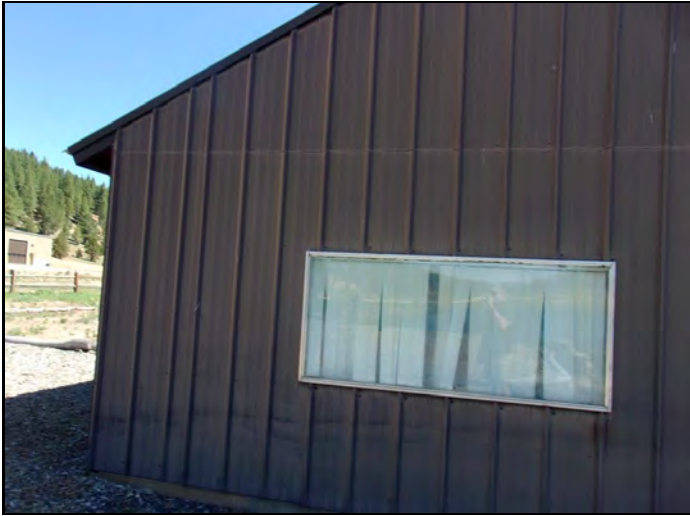
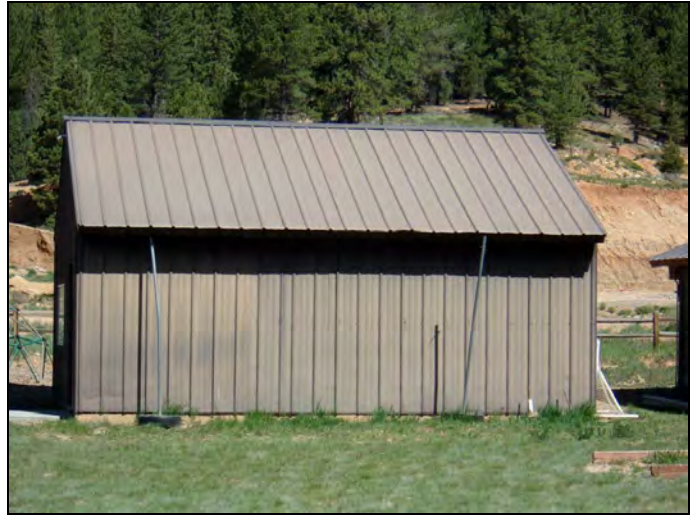
Comp #: 304 Metal Siding - Replace

The metal siding is in fair condition. We recommend funding to replace this component approximately every 40 - 50 years. Remaining life based on current age.

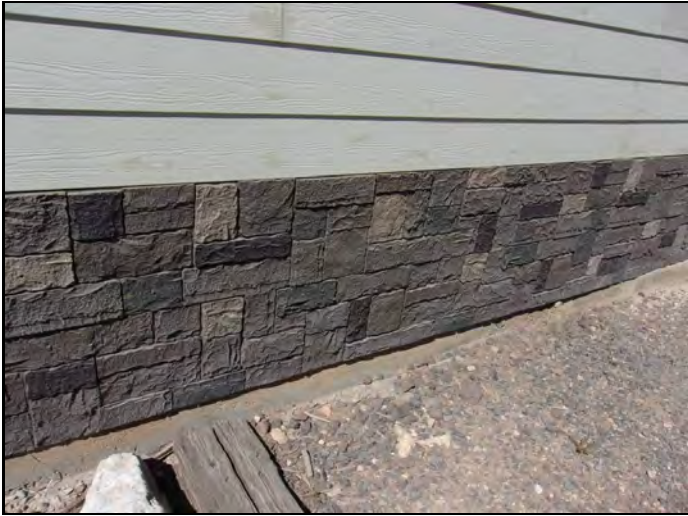
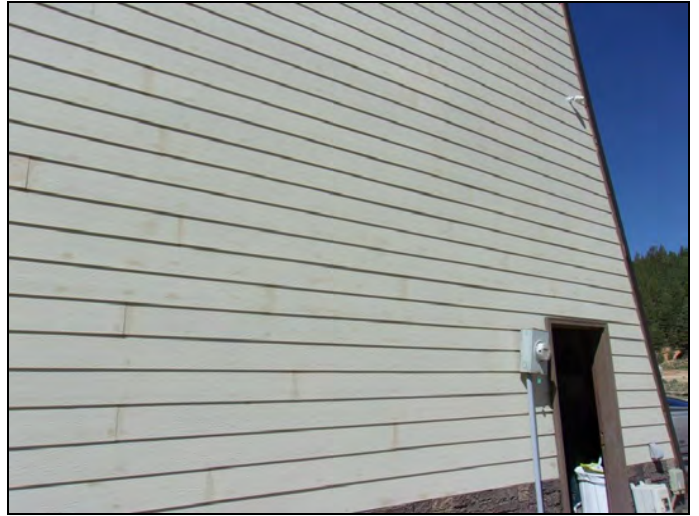
Comp #: 390 Barn Siding - Replace

The siding is in good condition. We recommend funding to replace this component approximately every 40 - 50 years. Remaining life based on current age.

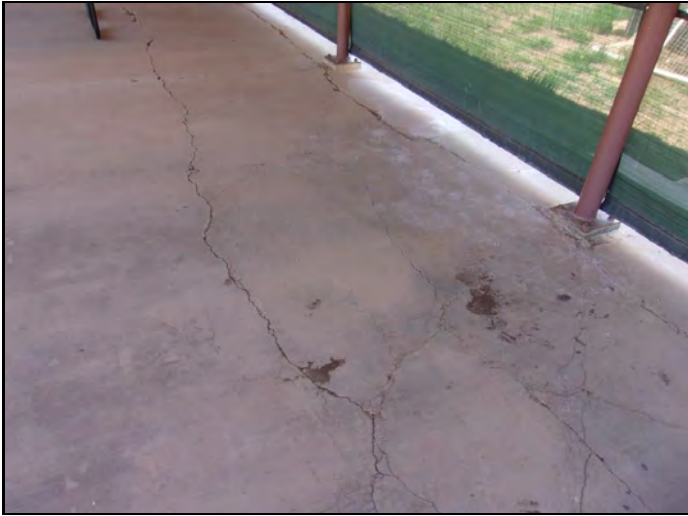
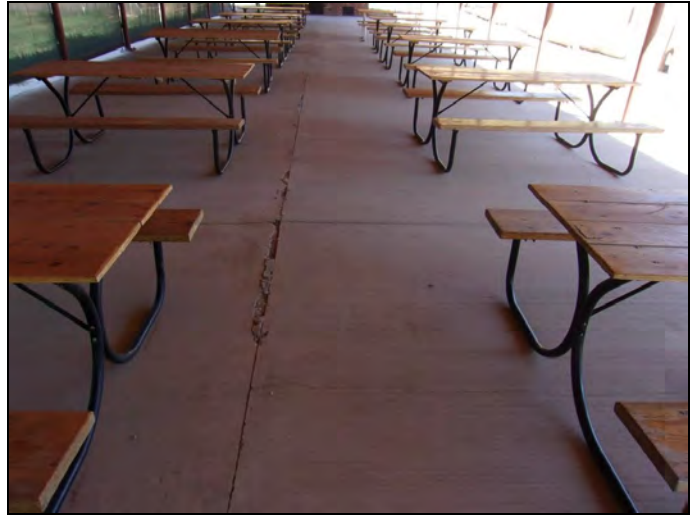
Comp #: 602 Concrete Slab - Pavilion - Replace

Research with the client reveals plans to replace this project in 2023. We recommend funding to replace this component every 30 - 40 years. Remaining life based on current age.

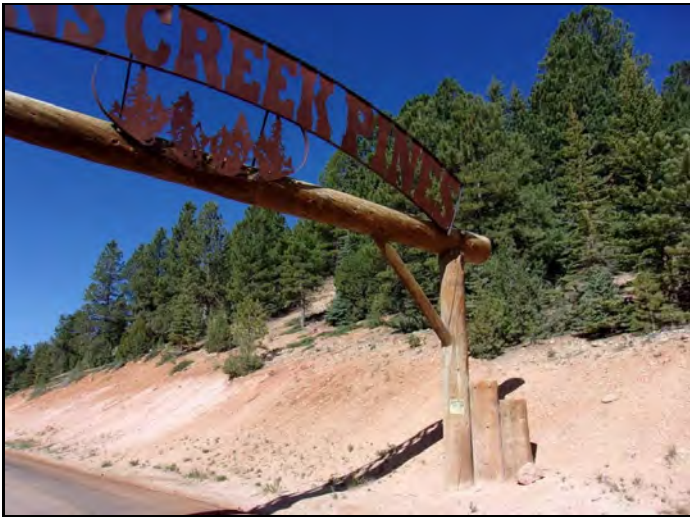
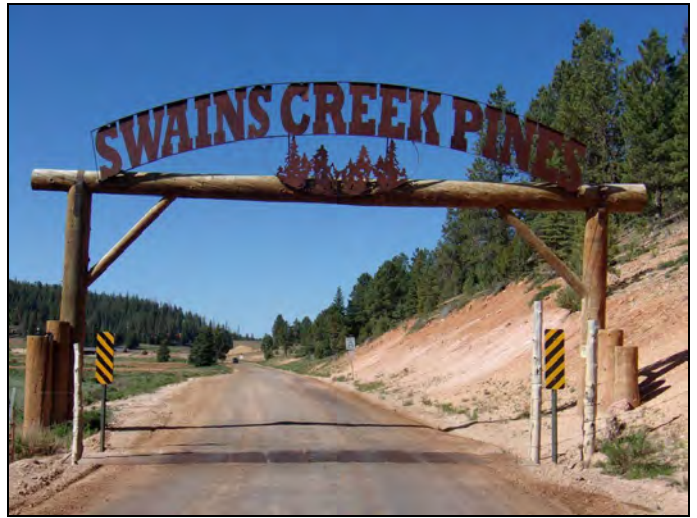
Comp #: 801 Entrance Arch - Replace

The entrance arch is in good to fair condition. We recommend funding to replace this component approximately every 30 - 40 years. Remaining life is based on current age.

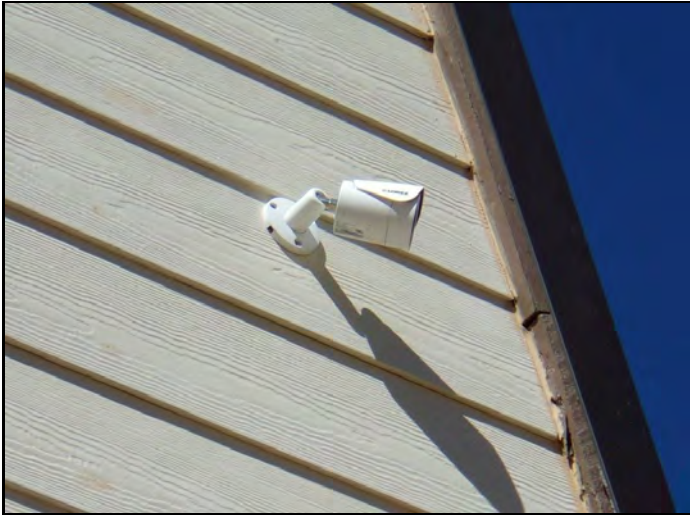
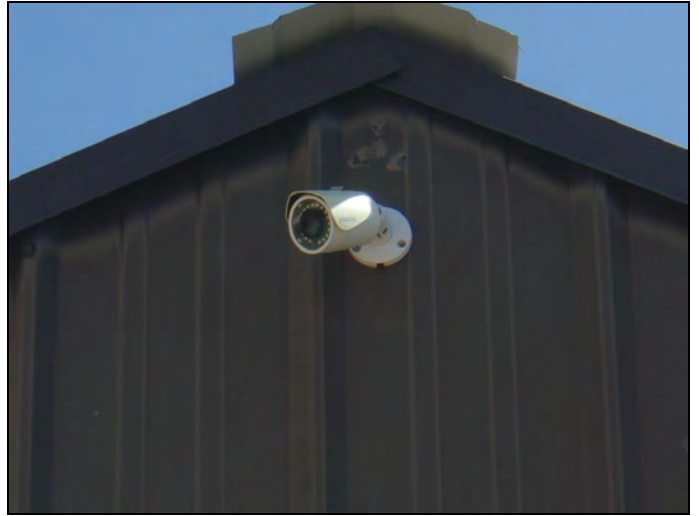
Comp #: 903 Camera System - Replace

The security camera system is in working condition. We recommend funding to replace this component approximately every 10 - 12 years. Remaining life based on current age.

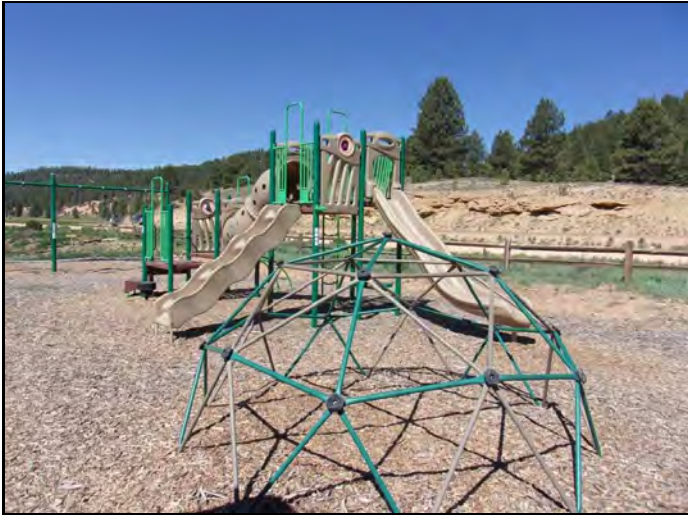
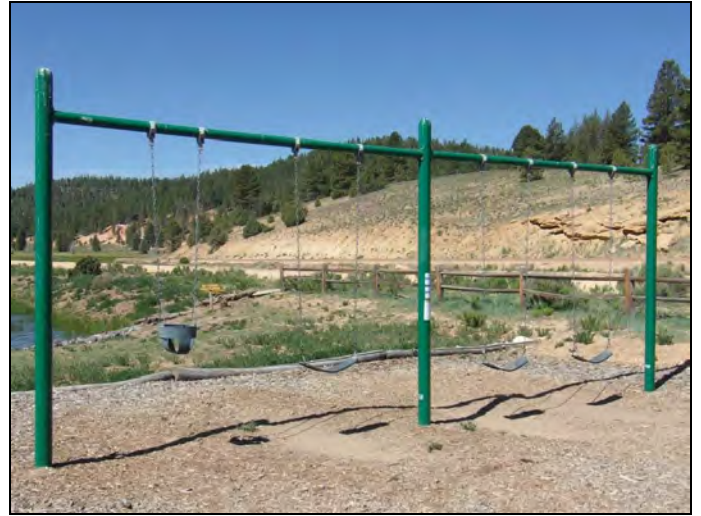
Comp #: 1301 Playground - Replace

The play structure is in good condition. We recommend funding to replace this component approximately every 20 - 25 years. Remaining life based on current age.

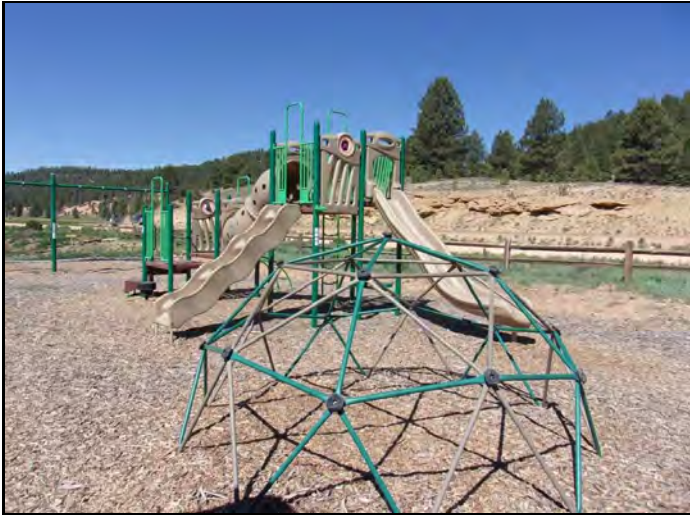
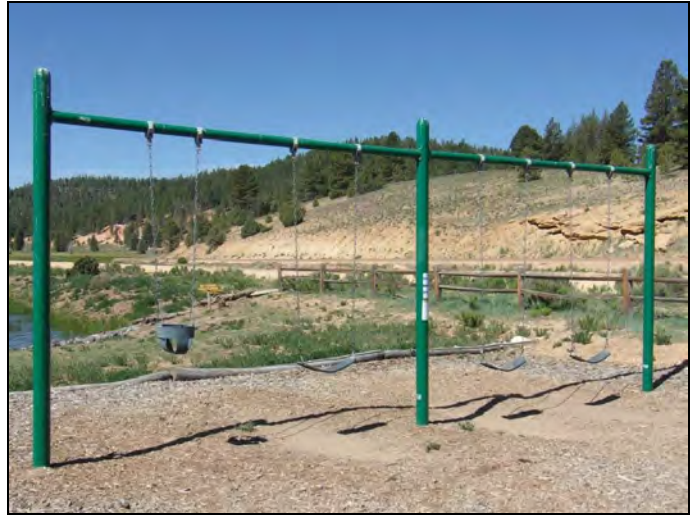
Comp #: 1303 Play Area Groundcover - Refill

The play area groundcover is in fair condition. We recommend funding to refill this component approximately every 3 - 5 years. Remaining life is based on current age.

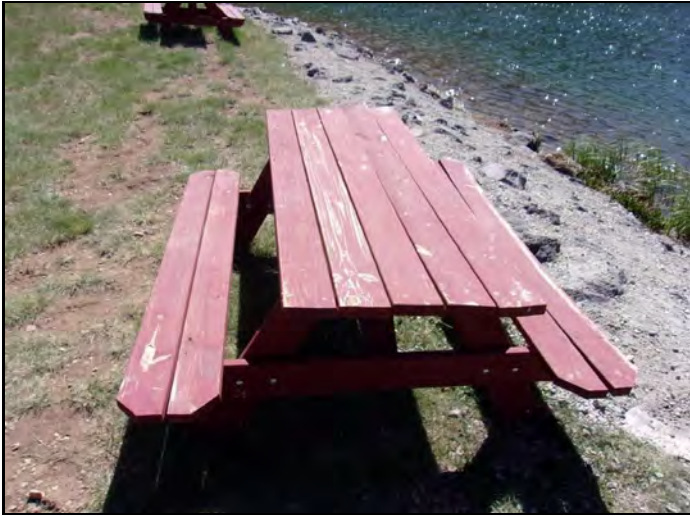
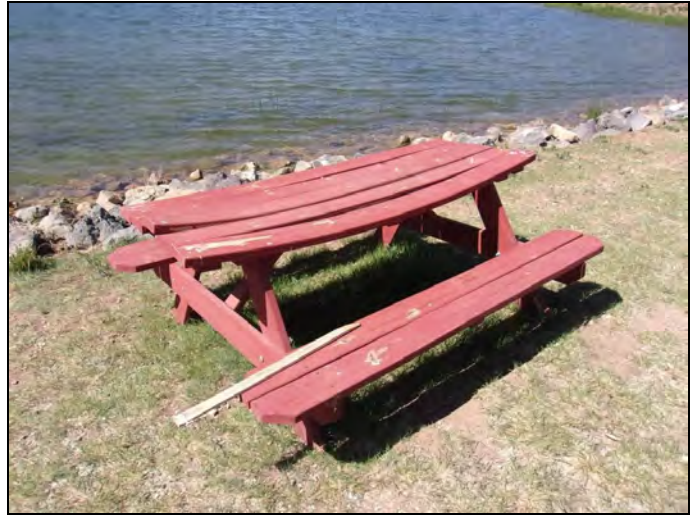
Comp #: 1306 Picnic Tables - Lake - Replace

This component has passed its useful life, but is still in functional condition. We recommend funding to replace this component approximately every 15 - 20 years. Remaining life based on current age and condition.

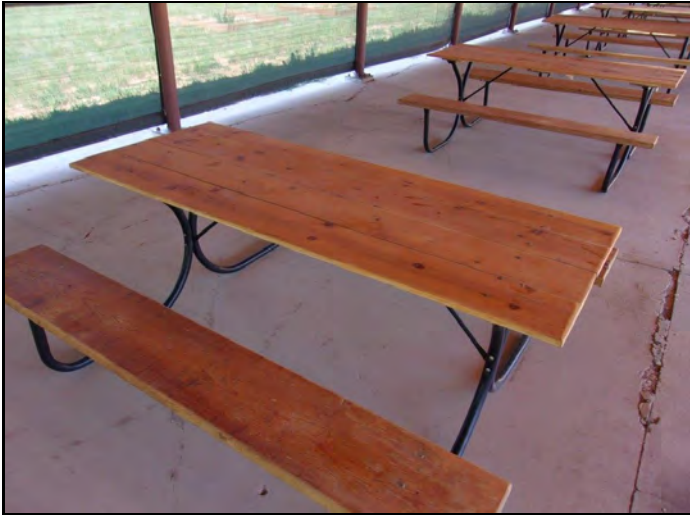
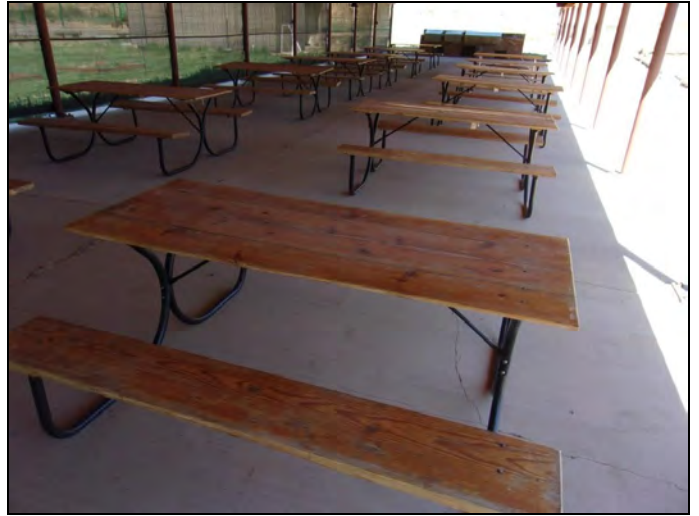
Comp #: 1306 Picnic Tables - Pavilion - Replace

This component has passed its useful life, but is still in functional condition. We recommend funding to replace this component approximately every 15 - 20 years. Remaining life based on current age and condition.

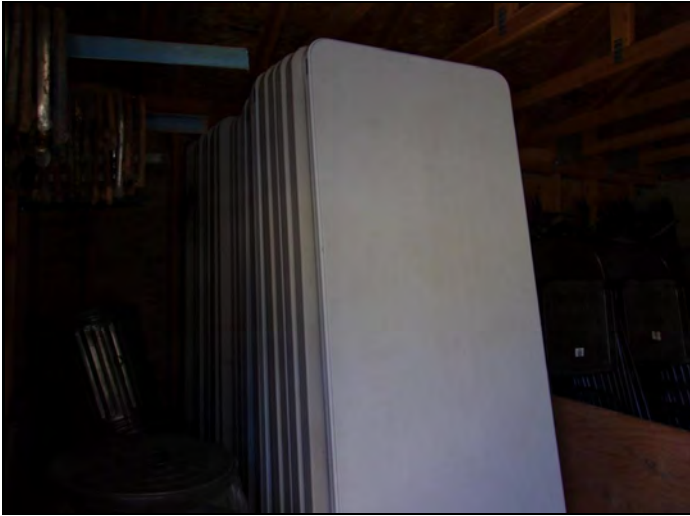
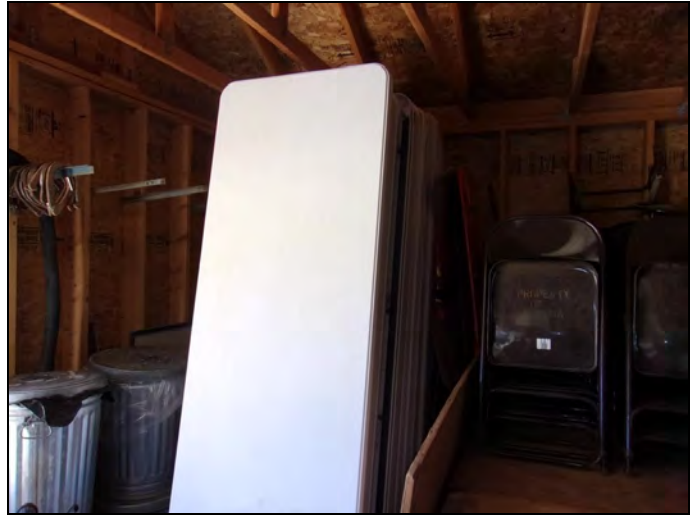
Comp #: 1307 Folding Tables - Replace

The folding tables are in good condition. We recommend funding to replace this component approximately every 15 - 20 years. Remaining life based on current age.

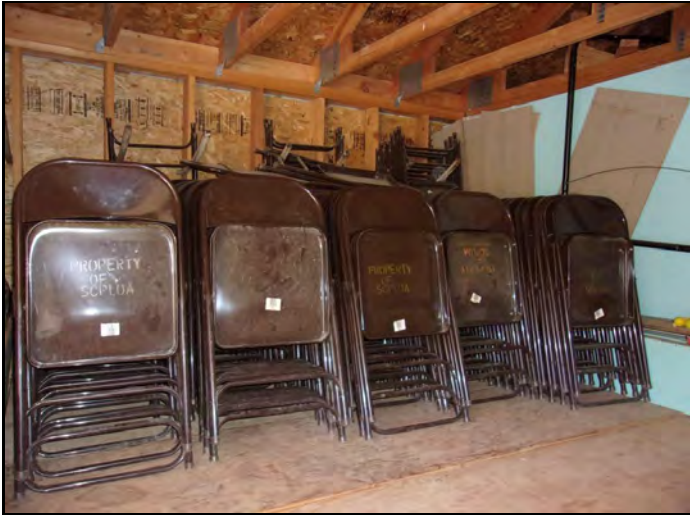
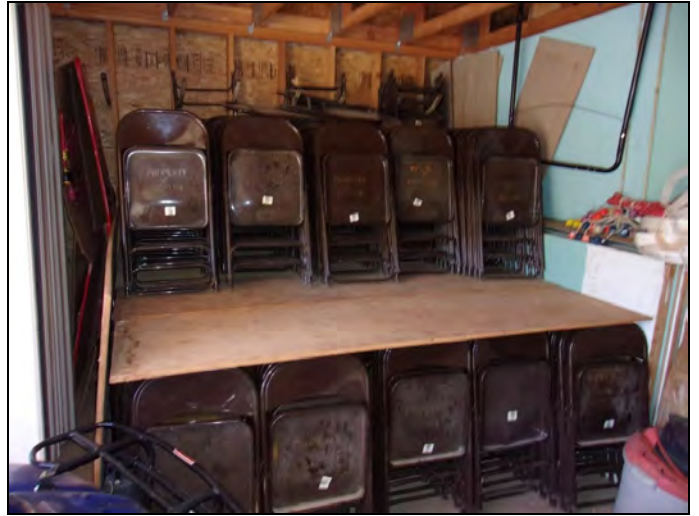
Comp #: 1308 Folding Chairs - Replace

The folding chairs are in good to fair condition. We recommend funding to replace this component approximately every 20 - 30 years. Remaining life based on current age.

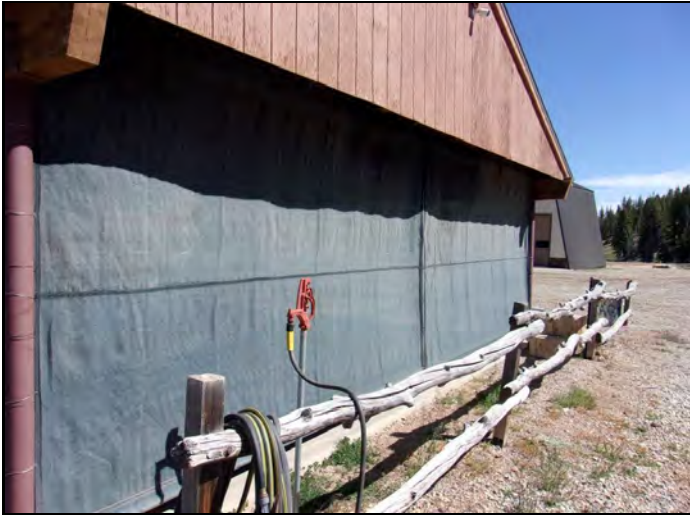
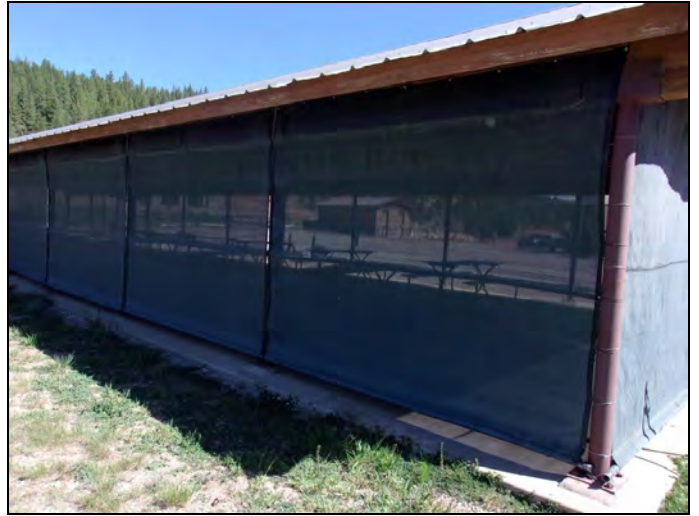
Comp #: 1390 Pavilion Windscreen - Replace

The windscreen is in fair condition. We recommend funding to replace this component approximately every 10 - 15 years. Remaining life based on current age.

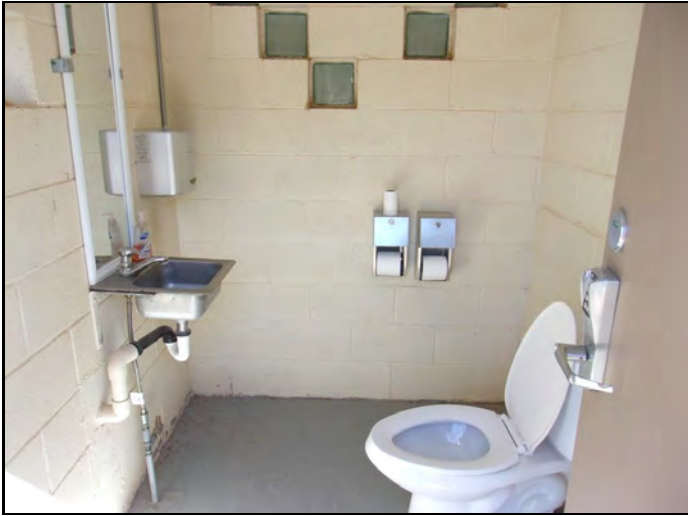
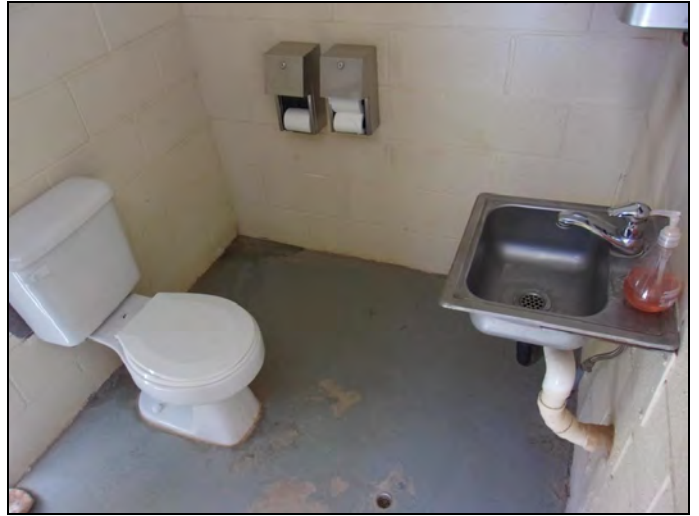
Comp #: 1413 Restrooms - Remodel

The restrooms are in good to fair condition. We recommend funding to remodel this component approximately every 20 years. Remaining life based on current age.

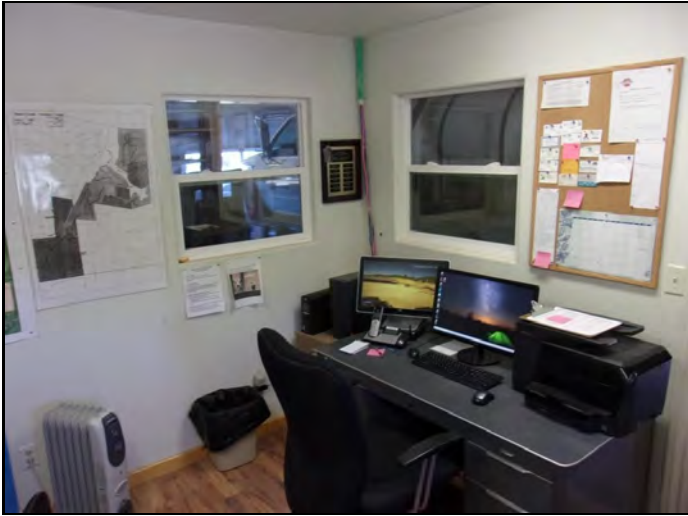
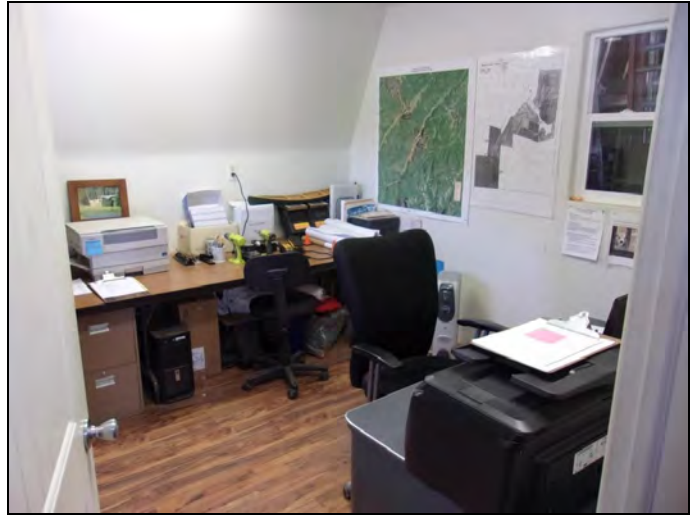
Comp #: 1416 Office - Remodel

The office is in good condition. We recommend funding to remodel this component approximately every 15 - 20 years. Remaining useful life based on current age.

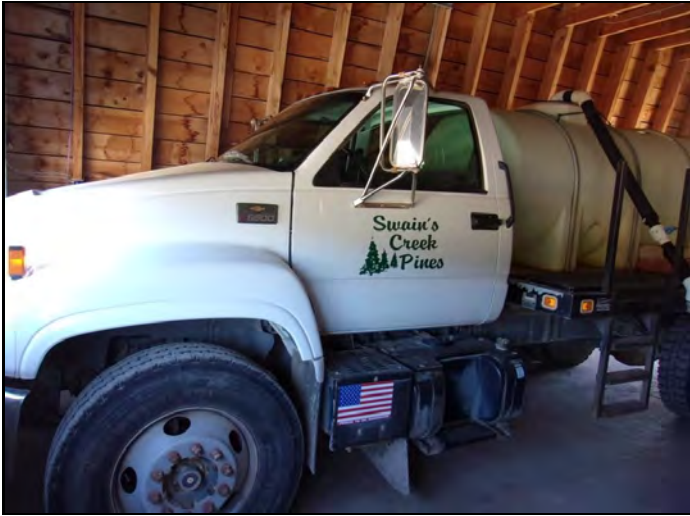
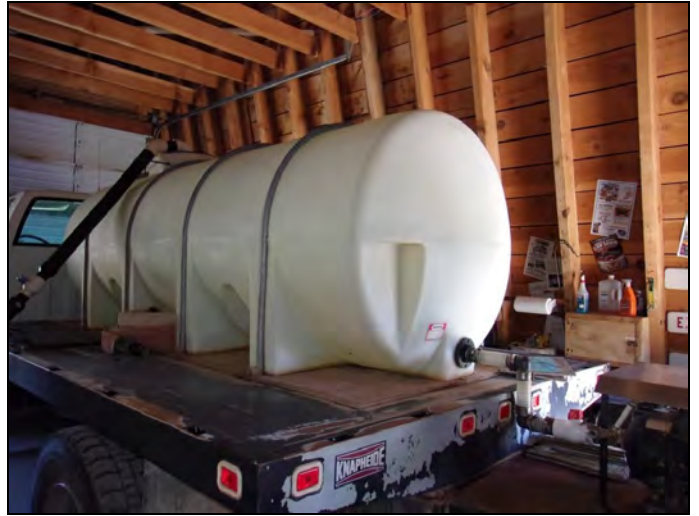
Comp #: 1901 Water Truck - Replace

The water truck is in working condition. Typically we recommend funding to replace this component approximately every 10 - 15 years, but due to low usage we increasing the useful life to 20 - 25 years. Remaining life based on current age.

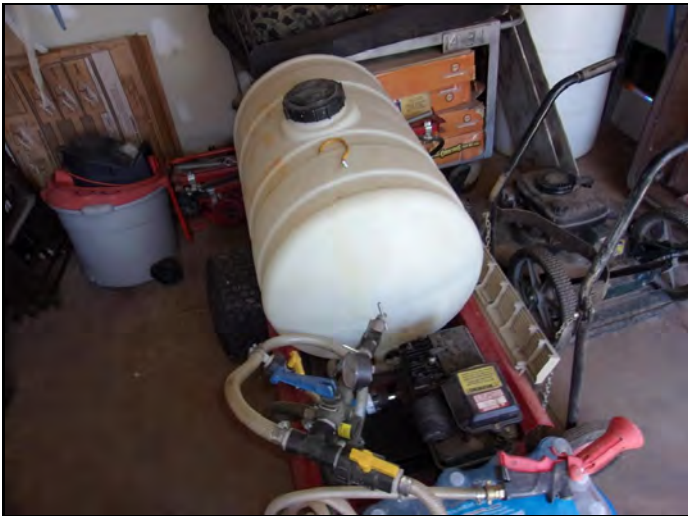
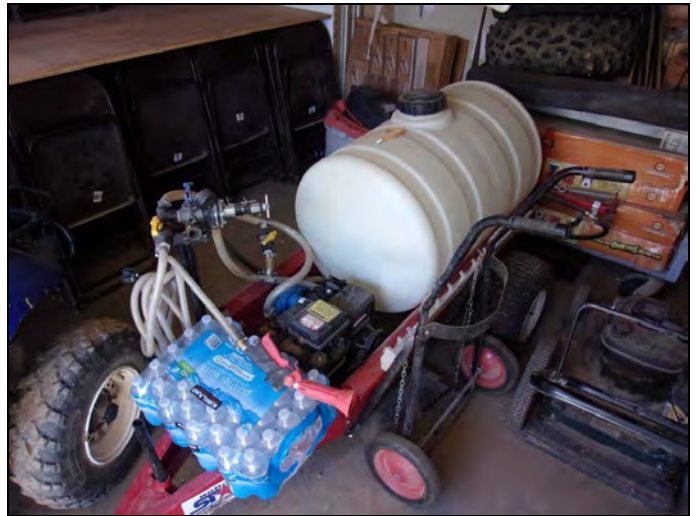
Comp #: 1903 Weed Sprayer - Replace

The weed sprayer is in working condition. We recommend funding to replace this component approximately every 10 - 15 years. Remaining life based on current age and condition.

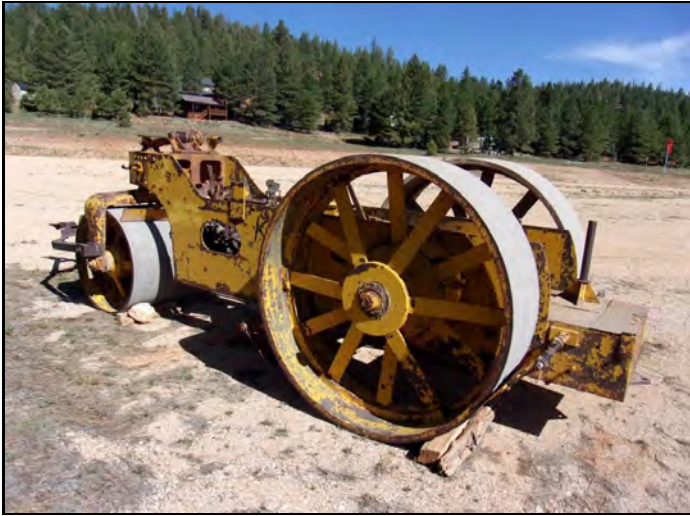
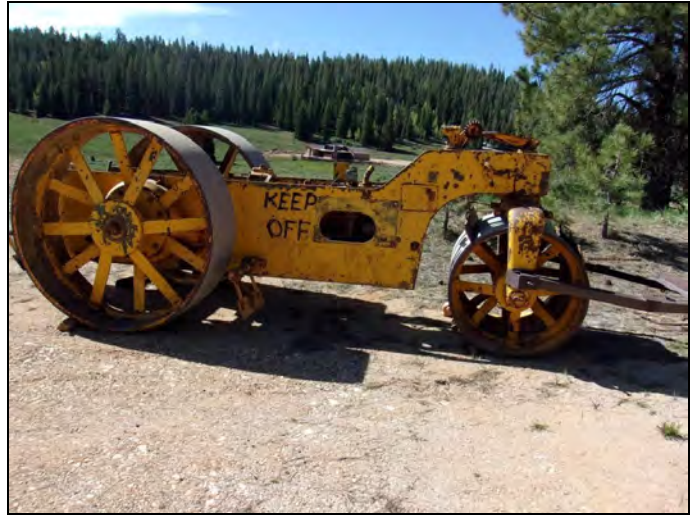
Comp #: 1905 Runway Roller - Replace

Research with the client reveals no plans to replace this component. The component is not in working condition, but is still usable for runway compaction when towed behind another vehicle.

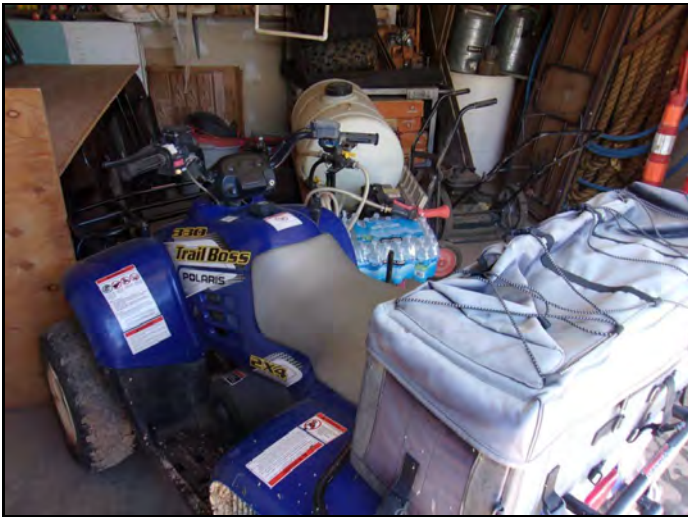
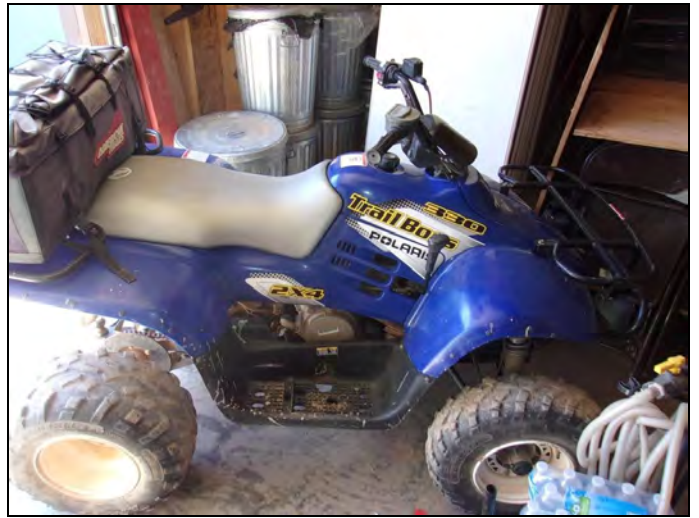
Comp #: 1906 ATV - Replace

The four wheeler is in working condition. We recommend funding to replace this component approximately every 10 - 15 years. Remaining life based on current age and condition.

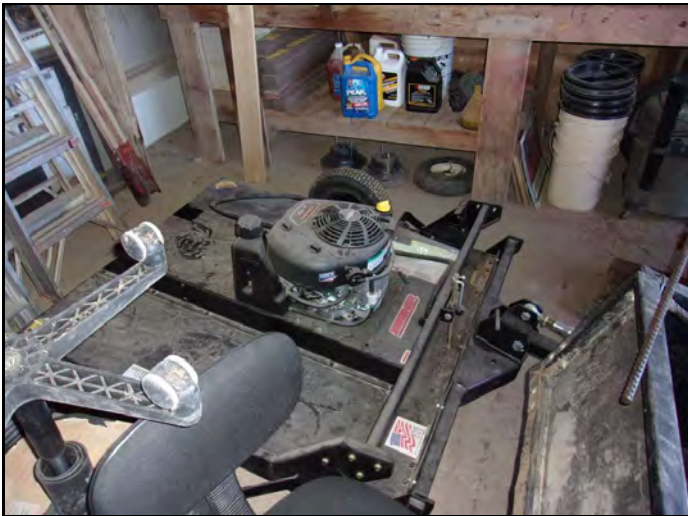
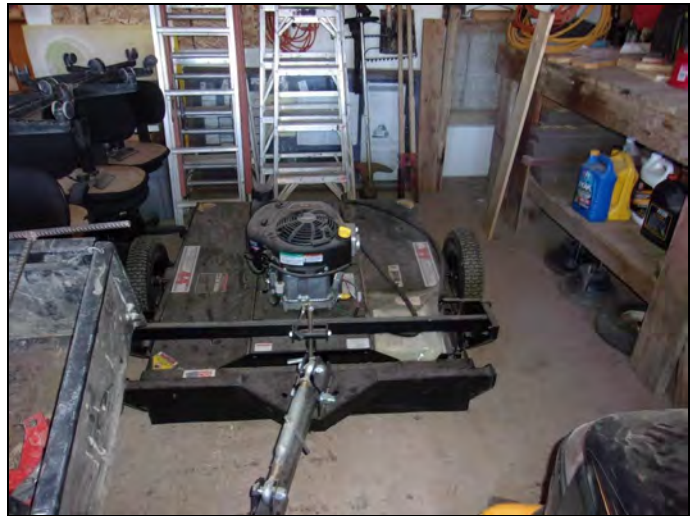
Comp #: 1910 Pull Mower - Replace

The mower is in working condition. We recommend funding to replace this component approximately every 8 - 10 years. Remaining life based on current age.

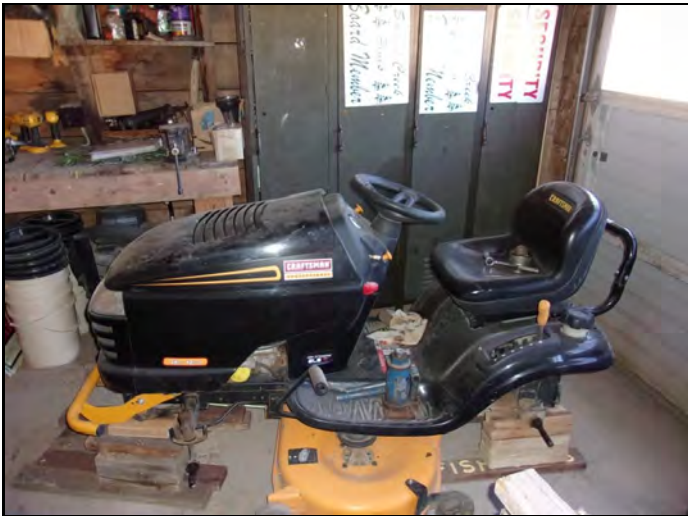
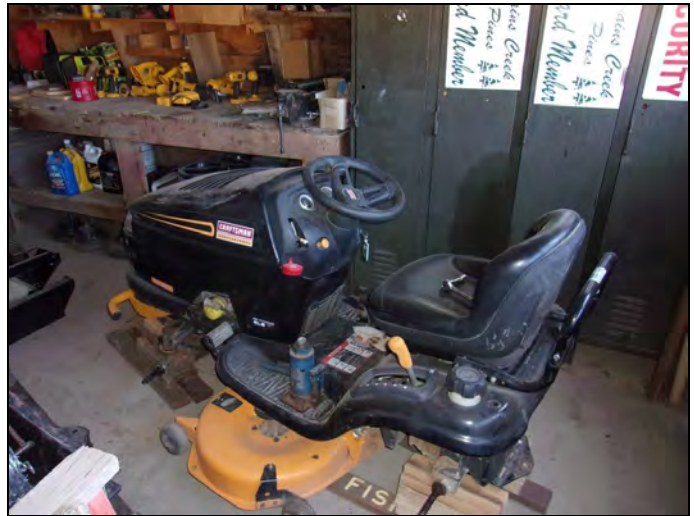
Comp #: 1911 Riding Mower - Replace

The riding mower is in working condition. We recommend funding to replace this component approximately every 10 - 12 years. Remaining life based on current age and condition.

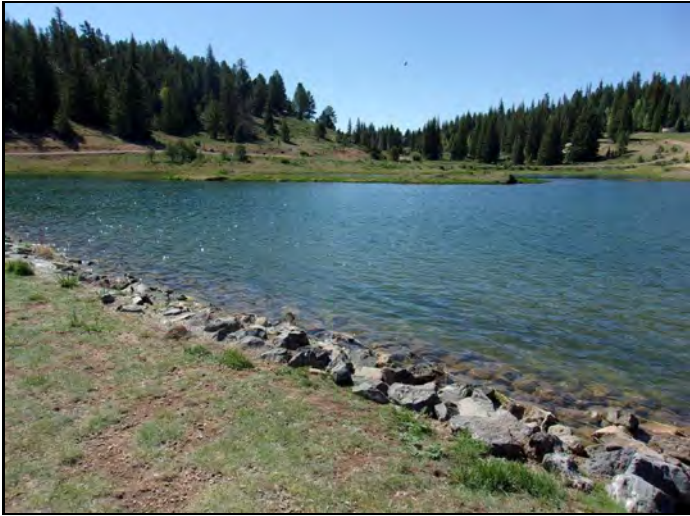
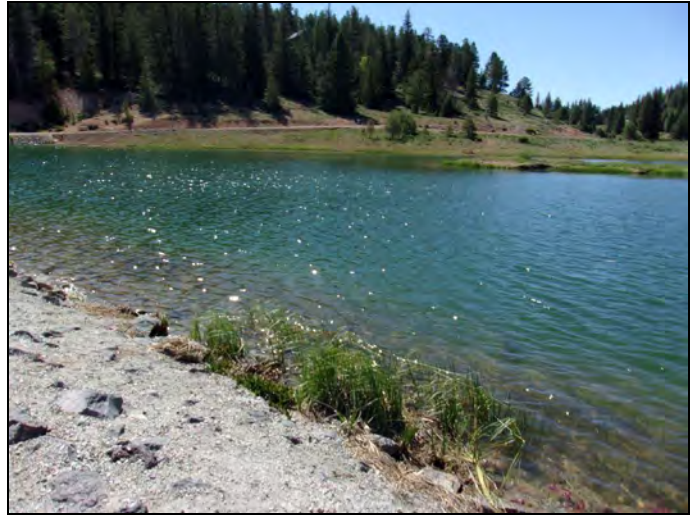
Comp #: 2201 Lake - Dredging

The lake dredge is in good condition. We recommend funding to dredge this component approximately every 25 years. Remaining life based on current age.
