Swains Creek Pines Lot O.A.
Duck Creek Village, UT

Report #: 55282-0
Beginning: January 1, 2026
Expires: December 31, 2026

RESERVE STUDY
"Full"

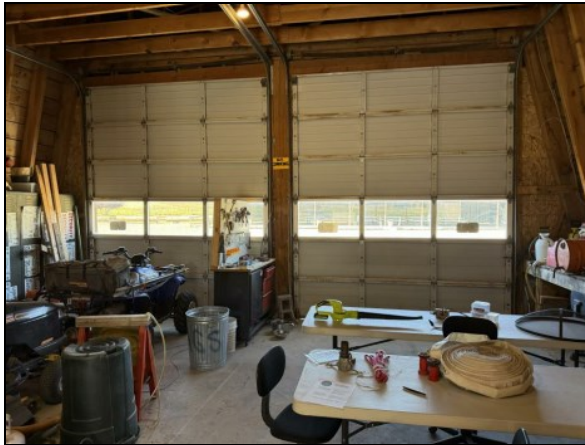
Comp #: 21490 Garage Car Doors - Replace

Garage doors determined to be in poor condition typically exhibit signs of moderate to advanced physical wear, including splintering/cracking of the door, especially in lower sections in contact with the ground, or more exposed areas. Surface wear is more pronounced at this stage and replacement with a new design may sometimes be warranted based on local aesthetic standards. Garage doors should have a long life expectancy under normal circumstances. Should be inspected and repaired as-needed as an Operating expense to ensure good function. Be sure to inspect internal components (springs, tracks, etc.) for damage and deterioration. For private garages, individual owners are presumed to be responsible for replacement of the garage door opener. Doors should ideally be replaced in all areas at the same time to maintain consistent appearance and obtain better pricing through economies of scale. There are a wide variety of styles available, and costs can vary greatly. Unless otherwise noted, estimates shown here are based on replacement with type comparable to existing doors.

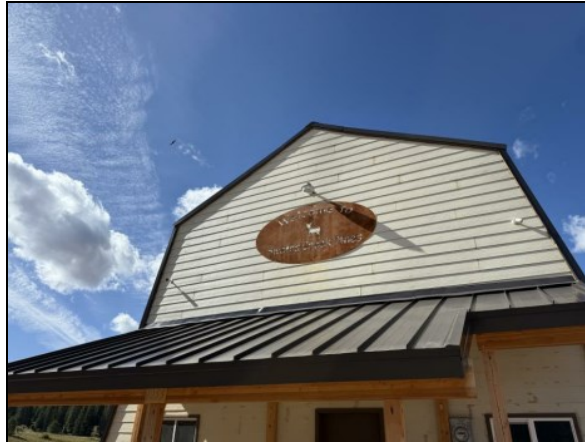
Comp #: 23020 Ext. Lights - Replace

Comments: Observed during daylight hours, but assumed to be in functional operating condition. As routine maintenance, clean by wiping down with an appropriate cleaner, change bulbs and repair as needed. In general, costs related to this component are expected to be included in the client's Operating budget. No recommendation for Reserve funding at this time. However, any repair and maintenance or other related expenditures should be tracked, and this component should be re-evaluated during future Reserve Study updates based on most recent information and data available at that time. If deemed appropriate for Reserve funding, component can be included in the funding plan at that time.

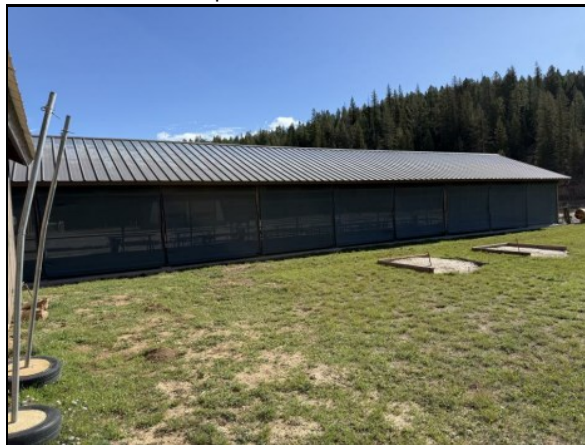
Comp #: 23070 Pavillion Wind Screens – Replace

Comments: Based on physical condition, the remaining useful life has been slightly extended.

Shade or canopy structures determined to be in fair condition typically exhibit more moderate signs of age including noticeable color fading loose/sagging material or other aesthetic problems. Attachments and hardware remain in serviceable condition.

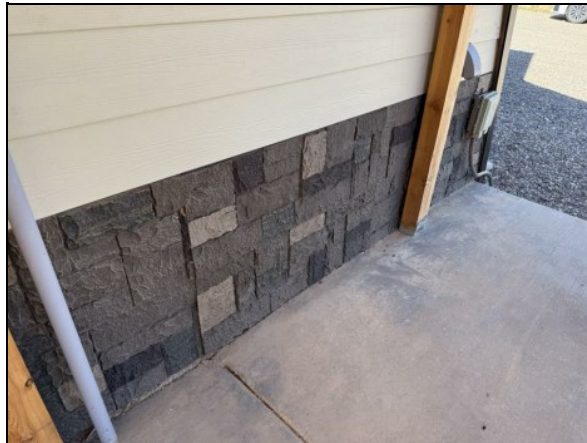
Comp #: 23370 Stone Veneer - Maintain/Repair

Comments: Brick or other masonry siding is typically a low maintenance surface that requires minimal infrequent repair. However in some cases (usually after several decades or more) the original mortar between bricks may require repointing to restore appearance and adequately protect against water intrusion. Repointing involves raking out a portion of the existing mortar and installing new mortar and continuing on until all affected sections have been replaced. In our experience there is not a well-defined predictable timeline for repointing work usually making this project inappropriate for Reserve funding. If re-pointing is a concern we strongly recommend further inspection by a qualified engineer and/or masonry specialist to diagnose existing conditions and recommend a scope of work. If warranted the Reserve Study can be adjusted to include funding recommendations going forward.

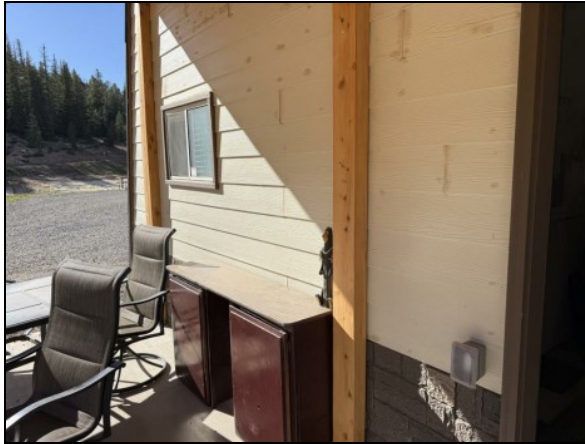
Fiber cement siding/trim sections determined to be in fair condition typically exhibit some color fading and inconsistency with minor isolated locations showing more advanced surface wear cracking splintering etc. Association Reserves does not specifically endorse any products manufacturers or vendors but James Hardie Building Products Inc. is the leading manufacturer of fiber cement siding and their website (www.jameshardie.com) is an informative resource for proper care and maintenance of fiber cement siding. Their Best Practices guidelines recommend the use of primers and topcoats that are designed and recommended for cement-based building materials such as fiber cement masonry brick or stucco. Two finish coats of high-quality exterior-grade acrylic paint are recommended. Their guidelines also recommend the use of elastomeric joint sealants complying with ASTM C920 Grade NS Class 25 or higher or latex joint sealants complying with ASTM C834. We recommend that the client consult with qualified exterior painting/waterproofing consultants and/or contractors to ensure that proper materials are used in painting and sealing the building siding. Plan for such projects at the interval shown here.

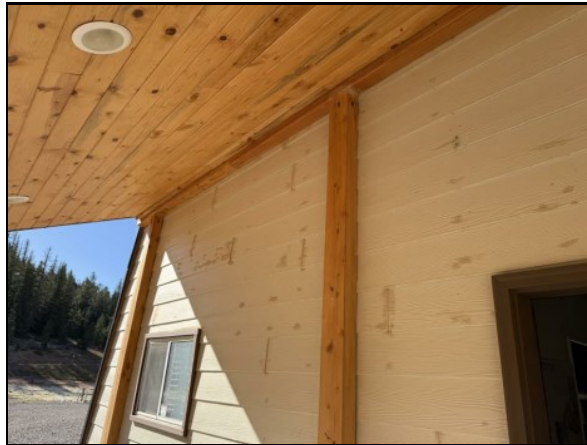
Comp #: 23390 Fiber Cement Siding - Replace

Comments: The surfaces appeared in fair condition. No broken or missing sections observed. Minimal evidence of cracking fading and peeling observed. Surface was painted. Actual material of siding was not confirmed since we conducted only a limited visual review. Siding is believed to be fiber cement. The largest manufacturer of fiber cement siding is James Hardie Building Products Inc. and www.jameshardie.com is a good source of information for best practices related to installation care and maintenance of the product. At this time there is no well-defined limit to the useful life of fiber cement siding. The client should review any available warranty documents to ensure proper steps are taken to maintain applicable warranties. As the product ages the client should conduct more detailed inspections beyond the scope of the visual inspection conducted during this engagement. Currently Hardie offers the choice of a 30-year non-prorated. James Hardie recommended maintenance tips include: • Patching - Dents chips and cracks can be filled using a good quality cement patching compound (acrylic mortar patch) which can be found at your local Home Center or Hardware Store. • Mold/Mildew - Remove using a commercial mold/mildew remover. Consult your paint manufacturer's recommendations before applying any mold or mildew remover. • Loose Siding or Soffit- Re-nail using a properly-sized corrosion-resistant fastener. • Caulk Replacement - When sealant is in need of replacing carefully remove existing caulk and replace with a high quality paintable latex caulk. For best results use a latex caulk that complies with ASTM-C- 834 ASTM C920 or better. Caulking should be applied in accordance with the caulking manufacturer's written installation instructions. • Paint Maintenance - Remove any damaged chipped or cracked paint. Prior to repainting make sure that the surface area is properly cleaned and prepared. Repaint immediately using 100% acrylic paint. • Note: For best results please refer to your paint manufacturer's written specifications for application rates and required topcoats or refer to James Hardie's Technical Bulletin No. S-100. The underlying waterproofing will degrade over time and may require replacement. No view of underlying waterproofing was part of our limited visual review. The client should plan for eventual replacement at roughly the time-frame below. Inspect and repair as needed using operating and maintenance funds.

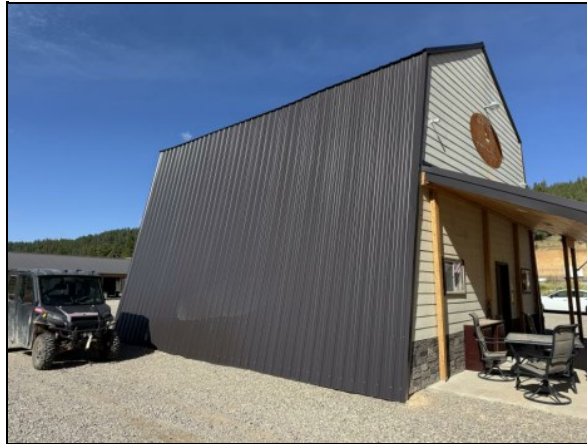
Comp #: 23410 Metal Siding - Replace (Barn)

History: Replaced in ~2022, per the client.

Comments: Replacement may ultimately be needed due to the failure of the underlying waterproofing degrading over the decades and/or the end of the useful life of the siding materials from general aging. Many factors influence the useful life including exposure to (or protection from) wind driven rain and the quality of the waterproofing and flashing beneath the siding. Evaluate the siding and the critical underlying waterproofing (typically building paper or house-wrap) more frequently as the remaining useful life approaches zero years. Adjust remaining useful life as dictated by the evaluation. Align with other exterior replacements for cost efficiencies and building envelope integrity when practical. Inspect annually and repair locally as needed using general maintenance funds. Metal panel can have a finish that is either field applied or factory applied. Most have factory applied finish which can last much longer than a field-applied finish. We assume that it is long lasting factory finish. Many factors influence the useful life including exposure to (or protection from) wind driven rain quality of the siding material and quality of the waterproofing and flashing beneath the siding. Almost all waterproofing systems will degrade over time (years or decades) as it ages. Project costs can vary depending upon materials chosen and the condition of the underlying structural framing when exposed. We recommend the Board conduct research well in advance in order to define scope timing and costs including plan for some margin of contingency.

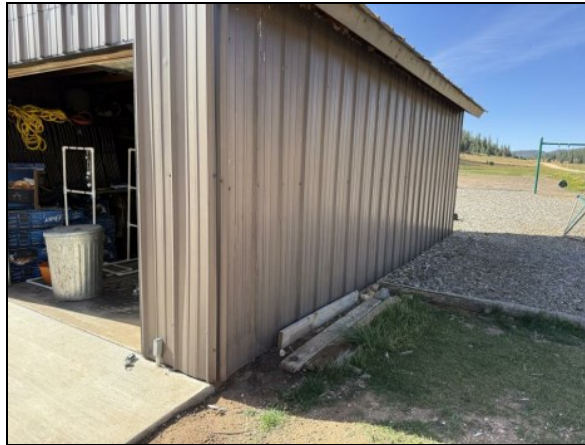
Comp #: 23411 Metal Siding - Replace (Storage Shed)

Comments: Metal surfaces were observed to be in fair condition. No broken or missing sections observed. No Minor rust and corrosion was observed. Slight fading and weathering noted. Replacement may ultimately be needed due to the failure of the underlying waterproofing degrading over the decades and/or the end of the useful life of the siding materials from general aging. Many factors influence the useful life including exposure to (or protection from) wind driven rain and the quality of the waterproofing and flashing beneath the siding. Evaluate the siding and the critical underlying waterproofing (typically building paper or house-wrap) more frequently as the remaining useful life approaches zero years. Adjust remaining useful life as dictated by the evaluation. Align with other exterior replacements for cost efficiencies and building envelope integrity when practical. Inspect annually and repair locally as needed using general maintenance funds. Metal panel can have a finish that is either field applied or factory applied. Most have factory applied finish which can last much longer than a field-applied finish. We assume that it is long lasting factory finish. Many factors influence the useful life including exposure to (or protection from) wind driven rain quality of the siding material and quality of the waterproofing and flashing beneath the siding. Almost all waterproofing systems will degrade over time (years or decades) as it ages. Project costs can vary depending upon materials chosen and the condition of the underlying structural framing when exposed. We recommend the Board conduct research well in advance in order to define scope timing and costs including plan for some margin of contingency.
